**ISCEAS-571**  
**Damage Factors of Pile Foundation of School Building**  
**Due to Seismic Performance of the Building**

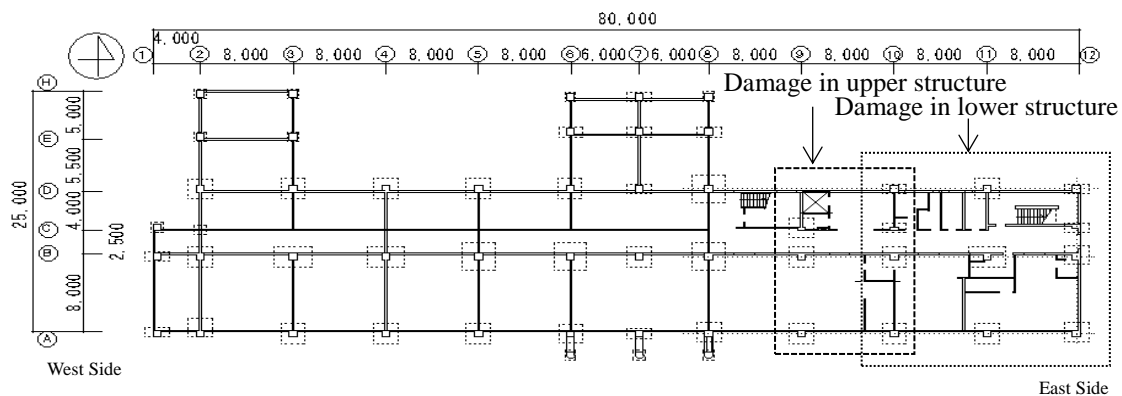
**Fig.1 Foundation plan**

The analysis object is 3-story Reinforced Concrete Construction school building with the pile foundations. Figure 1 shows the foundation plan and Fig.2 shows the framing elevation. There is no basement floor, and the longitudinal direction is framed structure with earthquake-resistant wall of 11 spans, the transverse direction is structure consist of earthquake-resistant wall of 5 spans. The longitudinal direction is called X direction and transverse direction is called Y direction. Most of the shear walls are located in the building has openings. Figure 3 shows the soil boring log. The foundation is independent footing. The piles are used pretension high concrete pile of  $400\phi$  (B type). The length of piles are 13m at Axis 1-4, 14m at Axis 5-9 and 16m at Axis 10-12. The ground is the soil type 2 (As shown in the book [2]).

According to the existing report (As shown in the report [3]), slight crack occurred at columns and walls in Axis 9-10 due to the earthquake, but there is a little exfoliation of the concrete, and reinforcement didn't exposed. The lower structure crushed at pile heads. Moreover prestressing steel have transformed and exposed. The building sunk at Axis 9-12 on the east side. In addition, liquefaction doesn't occur.

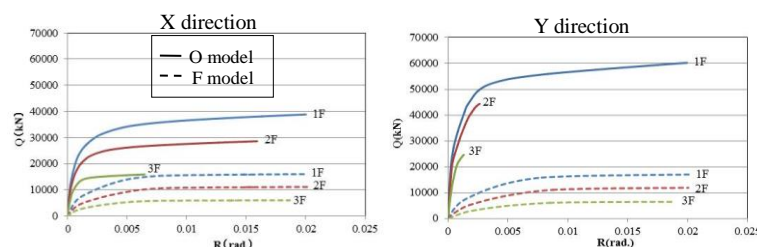
**Fig.4 Shear force – story drift angle relationship**

Figure 4 shows story shear force (Q)-story drift angle(R) relationship of the O model and the F model. In X direction, the base shear of the O model is about 2.6 times larger than that of the F model at the story drift angle 0.02rad. The cause is presence of many walls with openings in X direction. In Y direction, the base shear of the O model is about 3.5 times larger than that of the F model at the story drift angle 0.02rad.

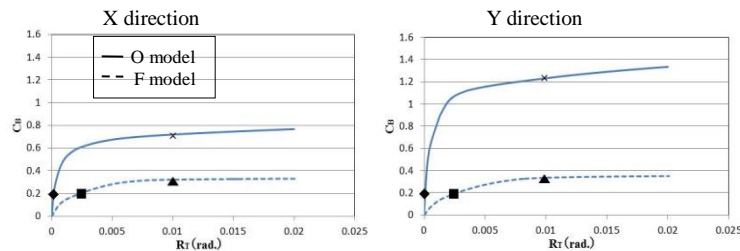
Fig.5 Base shear coefficient-representative drift angle relationship

Figure 5 shows base shear coefficient (CB) - representative drift angle (RT) relations of the O model and the F model. The representative drift angle RT is calculated by  $\delta/h$  (where,  $\delta$ : 3rd floor deformation,  $h$ : 3rd floor height). In X direction, the base shear coefficient of the O model is about 2.3 times larger that of the F model at the representative drift angle 0.01rad. In Y direction, the base shear coefficient of the O model is about 3.5 times larger that of the F model at the representative angle 0.01rad.

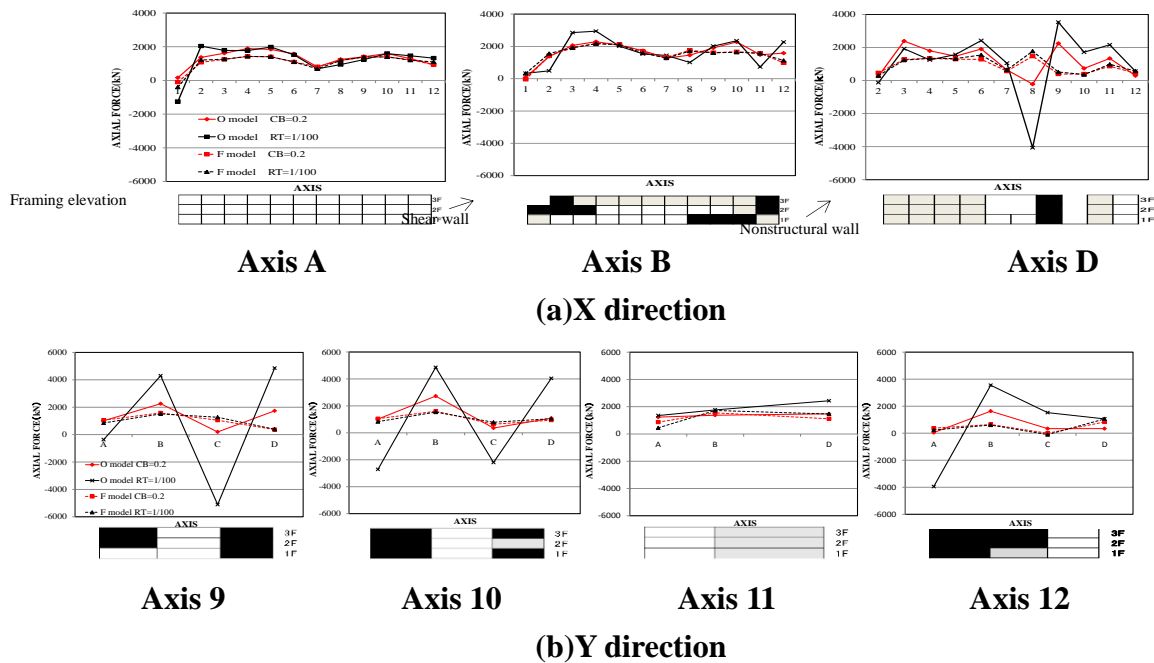
Fig.7 Axial force acting on pile head

Figure 7 shows axial force acting on the pile heads. The axial force acting on the pile heads is the vertical supporting point reaction force of the upper structure. It shows the Axis A, B and D that have plenty of walls, and also shows the Axis 9-12 that suffered the damage. The black coating of framing elevation in Fig.7 expresses a part that considered as a shear wall in the analysis model. According to the comparison of the axial force of  $CB=0.2$  of the O model in X direction between the damaged pile heads at Axis 10-12 and undamaged the pile heads at Axis 1-9, the axial forces at the damaged piles are not so large. Compressive and tensile the axial forces occur in the O model of  $CB=0.2$  in Y direction. In addition, looking at both models of  $CB=0.2$  and  $RT=1/100$ , it was found that the axial forces at the place with the shear wall become large when deformation become large.

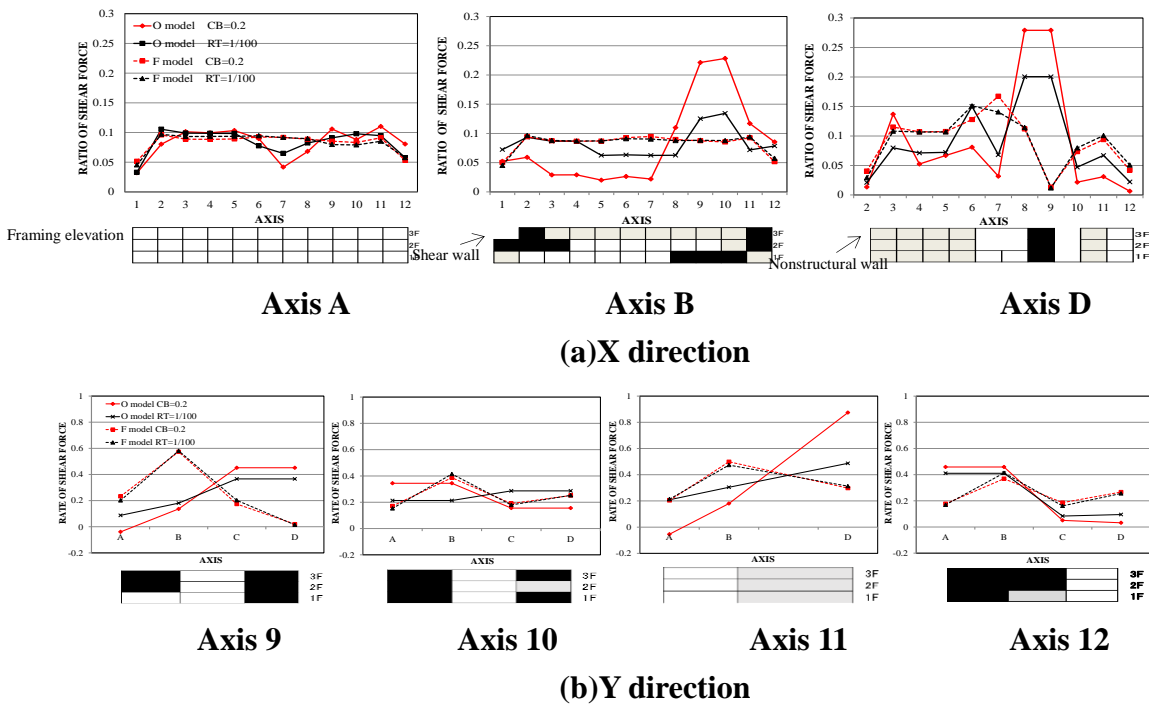
**Fig.8 Shear force acting on pile head**

Figure 8 shows the ratio of shear force of each axes acting on the pile heads. The ratio of shear force is derived from the shear force on each pile heads divided by the total shear force in the axis. The shear force acting on the pile heads is the lateral supporting point reaction force of the upper structure, and the inertial forces acting on the base portion are not included. Similar to Fig.7, it shows the Axis A, B and D that have plenty of walls, and also shows the Axis 9-12 that suffered the damage. Looking at the O model of  $CB=0.2$  in X direction, it was found that burden of the shear force increase at the place where has the shear wall. The burden of the shear force is large on the east side (Axis 8-11), it is supposed that it becomes a cause that the damage occurred in the east side (Axis 9-12).
